Retrofitting of RCC Beams Weak in Shear with BFRP Wraps

Abstract: This paper present an experimental investigation on retrofitting RCC beam weak in shear using BFRP wraps. BFRP stands for basalt fiber reinforced polymer. Six number of RCC beams of size 100x100x750mm were prepared and the reinforcement design was so that they were weak in shear. Of the six beams two were control beams. Control beams were tested up to failure and other beams were preloaded up to 70% of the failure load of control beams. Preloaded beams were then retrofitted by using BFRP. BFRP was wrapped in two pattern, one is wrapping in the shear zone in U manner and other pattern is the diagonal wrapping on two side faces at $\pm 45^\circ$. Retrofitted beams were then tested up to failure. All the beams were tested under two point static loading. Load deflection behavior, first crack load, ultimate load, failure mode and crack pattern were analysed. The results depicted that BFRP wraps improved the ultimate load carrying restored the stiffness of the member. BFRP wraps changed the brittle mode of failure to a ductile one.

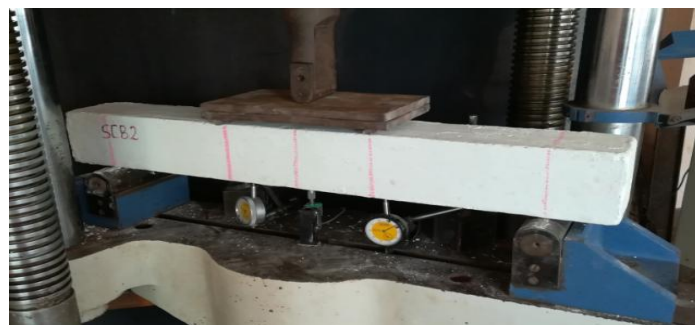
Fig.2 Test setup

All the six beams were tested under two point loading. UTM of capacity 600kN is used for testing. LVDT was kept at the mid span of the beam to measure central deflections. Two dial gauges were kept on the tension side of the beam to measure the lateral deflections at L/3 distances. The test setup is shown in Fig.2.

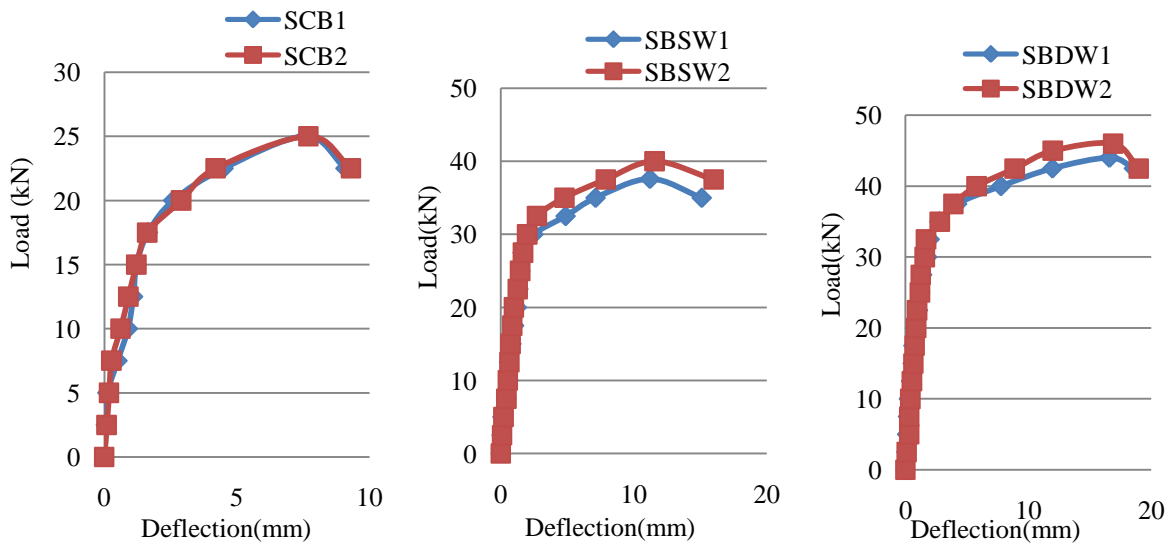
Fig.4 Load deflection curve of each beam

The load deflection histories of all the beams were recorded. The deflection at one third span and mid span were noted. For comparing load deflection behavior mid span deflection was considered. Load Vs mid span deflection of each beam in a scheme was compared. Fig.4 shows the load deflection curve for each beam in scheme. From the graph it can be seen that the behavior of each beams in a scheme is identical. This conforms the accuracy of the experiment. In the case of retrofitted beams, it conforms that the retrofitting was performed in well defined manner. For comparing control beam with the retrofitted beams, beam with maximum failure load from each scheme was chosen. The mid-span deflection of retrofitted beam was compared with that of control beam. Fig.5 shows the comparison of load deflection behavior of control beam, and retrofitted beams.

Control beam failed in brittle manner. Retrofitted beams shows higher load carrying capacity and showed large deflection before failure. The failure mode changes from brittle nature to ductile nature. It can be seen that the stiffness of the retrofitted beam has increased. At the initial stages of loading the BFRP wraps restore the stiffness of the retrofitted beams to the level of control beam. At later loading stages stiffness of the retrofitted beams was high. Stiffness of the diagonal wrapped beam was very high compared to control beams because diagonal wrap prevents the propagation of crack. Diagonal wraps provide lateral confinement to the beam specimens. Stiffness of the beam wrapped in shear zone is less than that of the diagonally retrofitted beam. This may be due to the absence of any wrapping in the flexural zone, where crack may initiate and propagate.

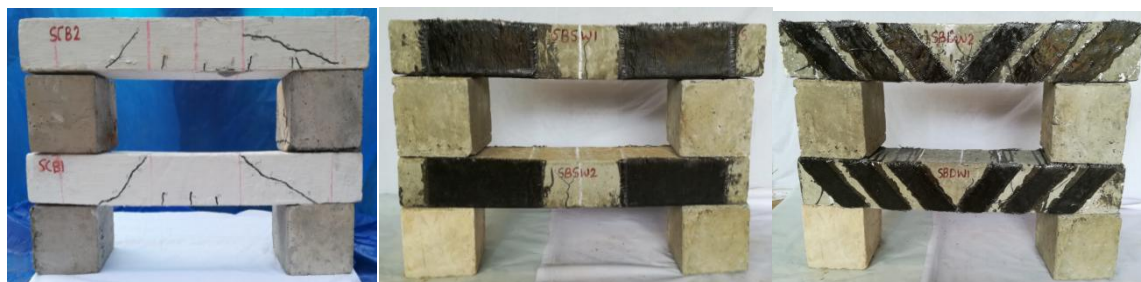
Failure mode and crack pattern of control beam and retrofitted beams were noted and explained separately. For control beams, since the beam specimens were weak in shear, the shear crack tends to propagate at the initial stages of loading itself. Very small flexural cracks were observed in the flexural zone at later loading stages. As the load increases, shear crack widens and propagates rapidly. The specimens clearly failed in a brittle manner with sudden destruction. Both the control beams failed in same manner. Fig. 6 shows the failure pater of all beams. For beams wrapped in the shear zone, at the initial loading stage a small vertical crack regenerated in the flexural zone. As the loading increases, these crack started to propagate slowly in vertical direction. At later loading stages, this crack started to propagate in inclined direction. The failure mode was flexural shear failure. That is BFRP wraps on the shear zone changed the mode of failure from brittle to ductile which gives sufficient warning before failure. In both the beams only single crack was seen, which widened as load increased and both the beams failed in similar manner. There was no rupture or debonding of the BFRP. There was no concrete crushing. Fig.7 (a) shows the enlarged view of the crack pattern.

(a) Control beam (b) Shear zone wrapped beam (c) Diagonal wrapped beam
Fig. 6 Failure pattern
